Milano, 23/02/2011

Nr. 2AN-7753

**Results of scientific studies on the present painting,
oil on copper (52 x 41 cm)**

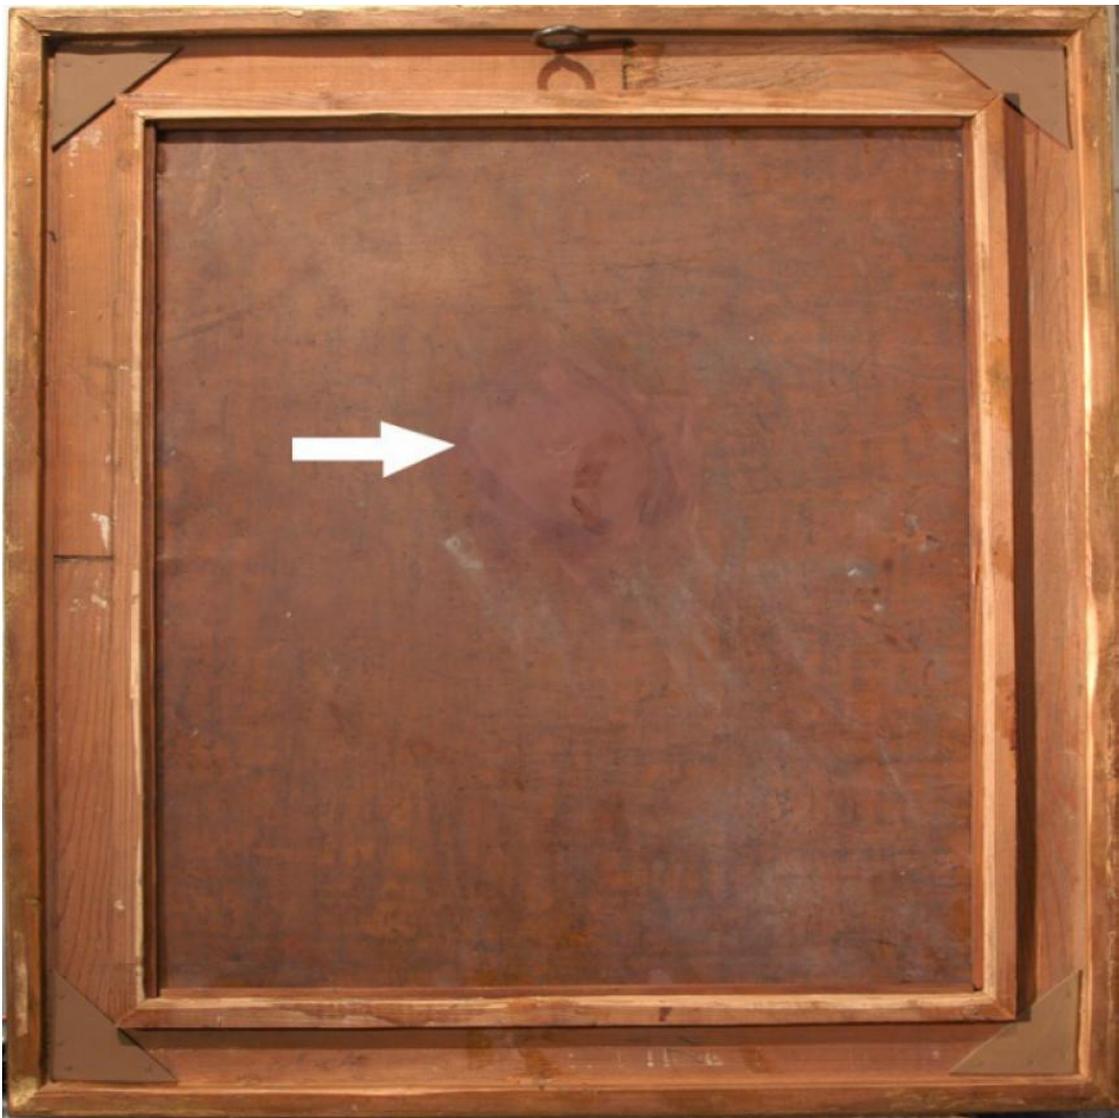
The painting is by and large in good condition except for one place: in the middle of the right ribs Christ can recognize a restoration.

On the back of the photograph can be seen both the metal as well as the above-mentioned restoration in the middle (see arrow).

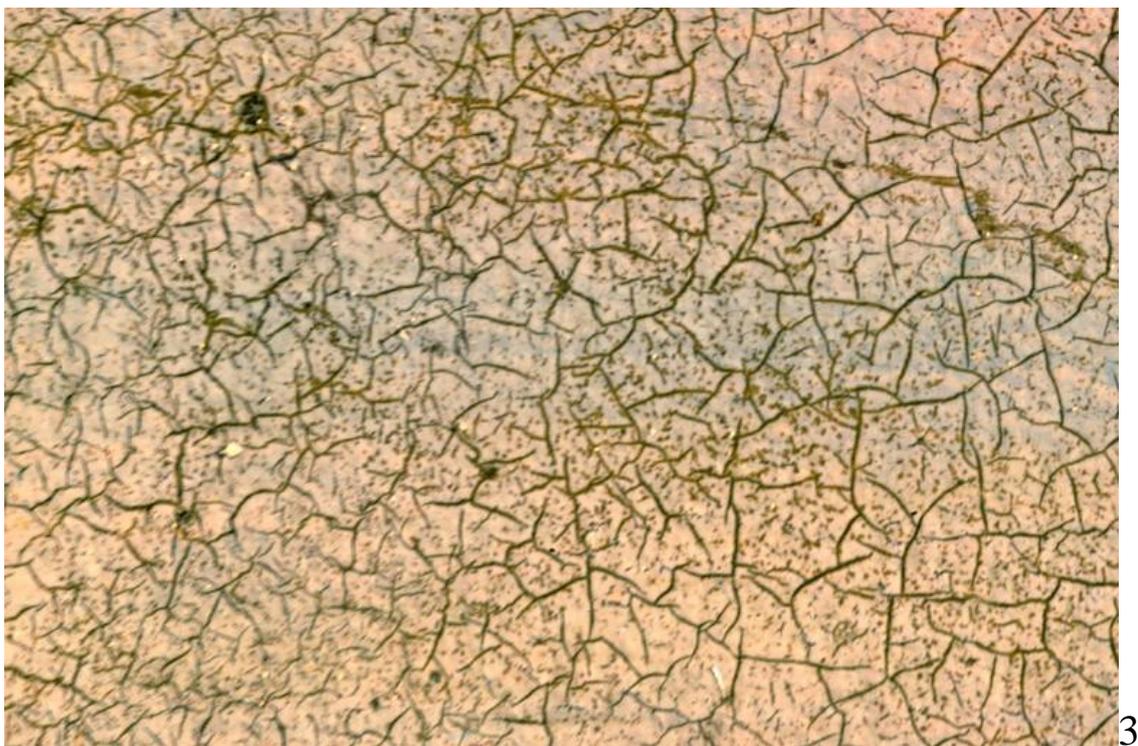
In many areas of the image has consistently branched crackle formed: It is according to the different colors at different depths and appears most evident in the lighter areas, as these are less elastic due to lower concentration of binder and therefore tend to form cracks, as to deform. (Macro photo No. 3).

The characteristic shape of rectangular hardly cracks forming the crackle, is due to the properties of the material of the image carrier. Namely copper tends to vary according to temperature, expand or contract. This then causes the typical for this material crackings.

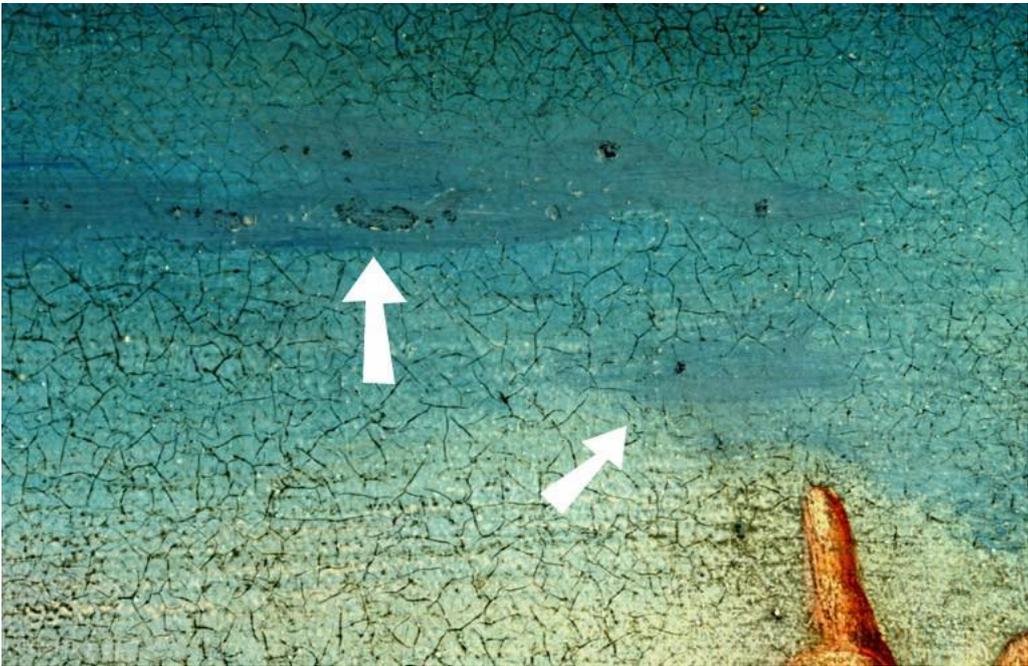
From the same microscopic analysis are numerous little restorations easy to recognize because they are the ends of the cracks that form the crackle, cover. (Macro photo 4 and 5).

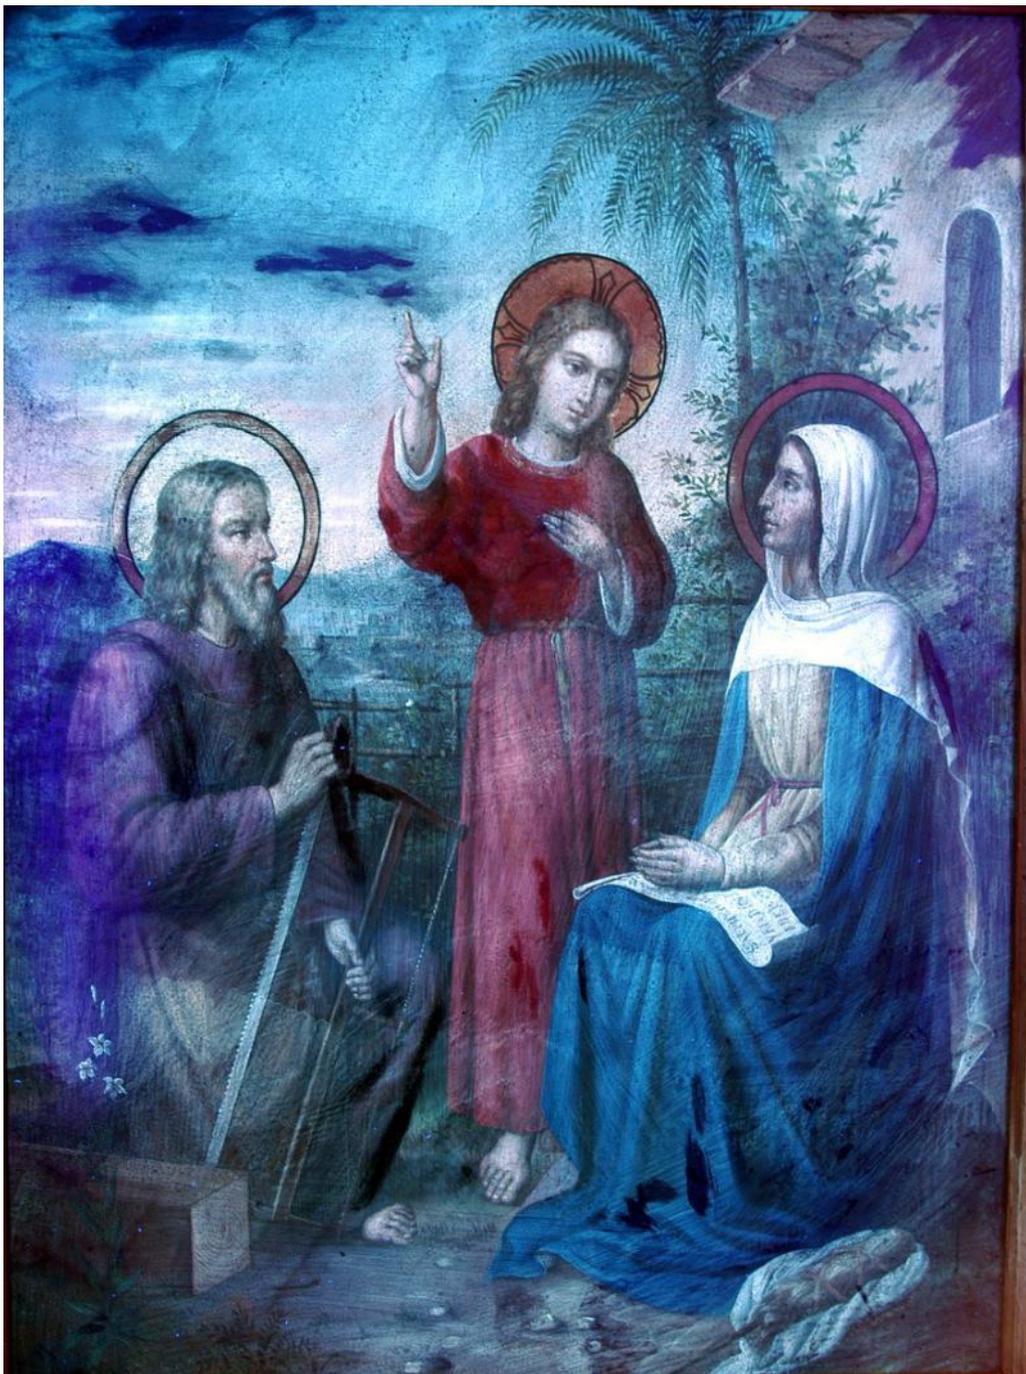
10

A more detailed analysis of the image with Wood's light recent restorations have come to light that appear as dark spots. They are particularly at the upper right corner (as seen by the observer), in the right rib area of Christ, visible in some parts of the halos of the sky and the background, while both the faces and the majority of the links are intact.

(The photo No.10 was prepared with the help of special filters and digitally remastered)

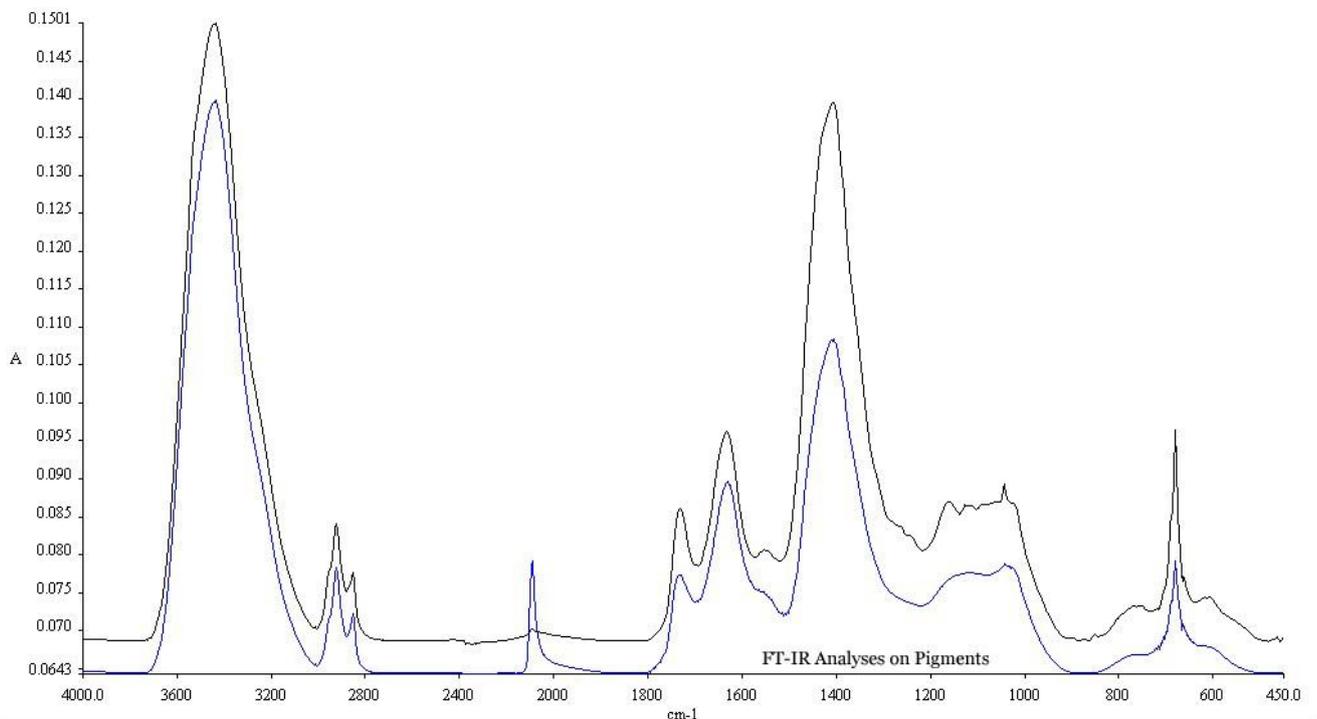
The investigation revealed that the white of white lead, and zinc white called, exists (it does not Titanium White was found that until 1920 he had in painting use), while the blue, Prussian blue contains' (see attached spectrum).

Furthermore, you could a small amount of paint binder (peak at 1735 cm⁻¹) to determine what is confirmed by an advanced dehydration of the oil.

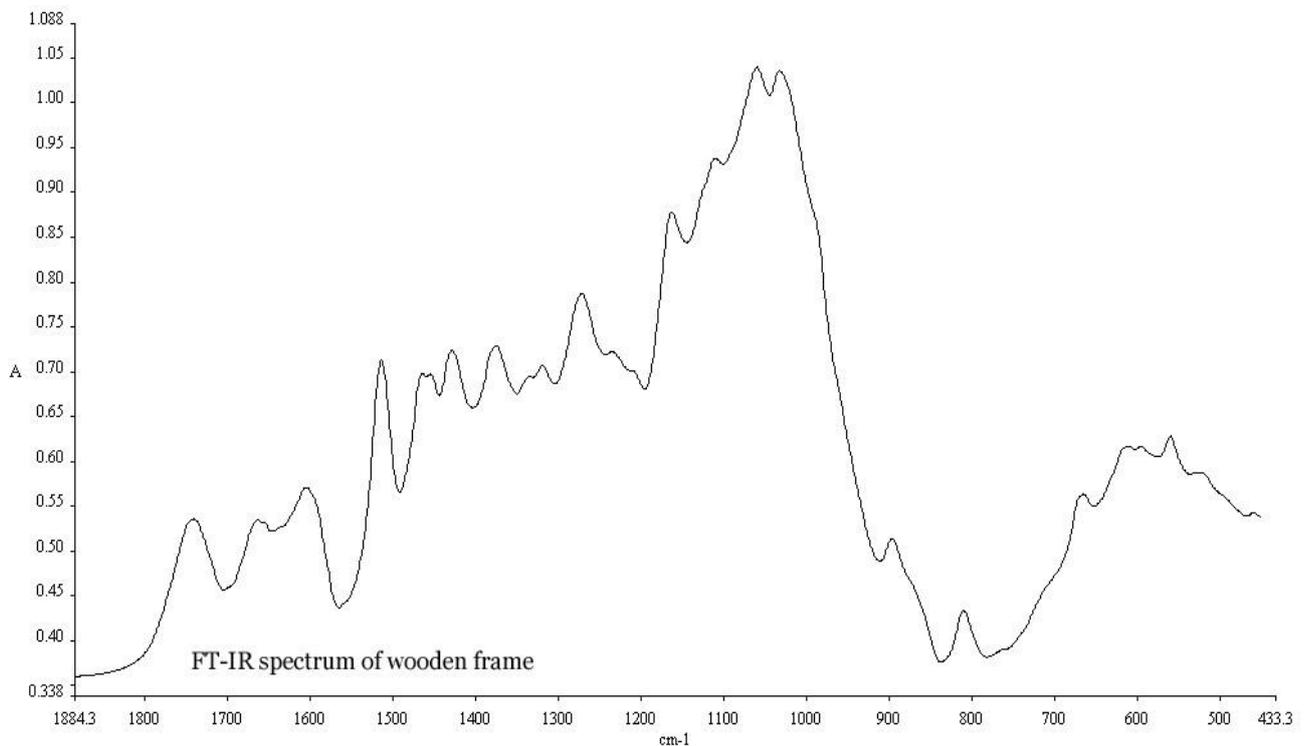
Species = conifer

age of the wood = 60 (+ / - 15 years)

This result suggests that the painting was part of the image added later and so is of a later period.
