Milano, 23/02/2011

Nr. 2AN-7753

**Results of scientific studies on the present painting,
oil on copper (52 x 41 cm)**

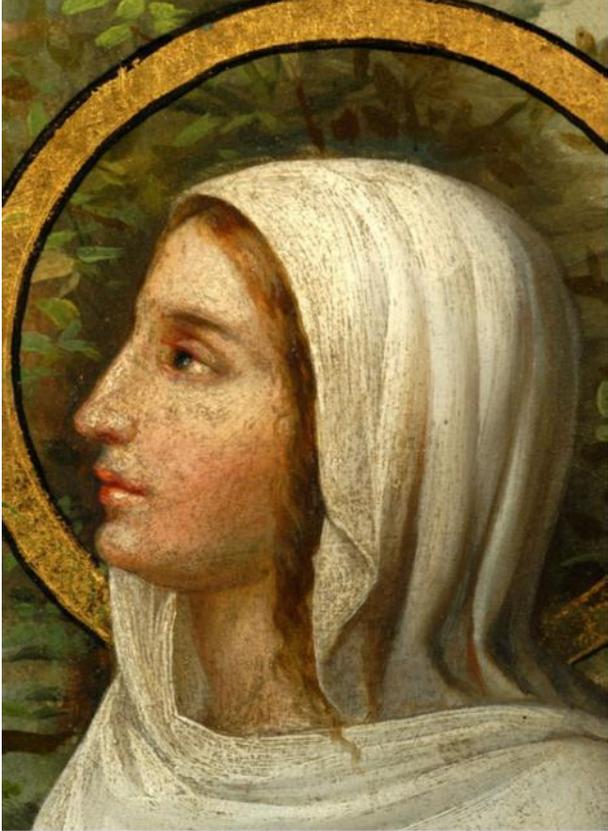
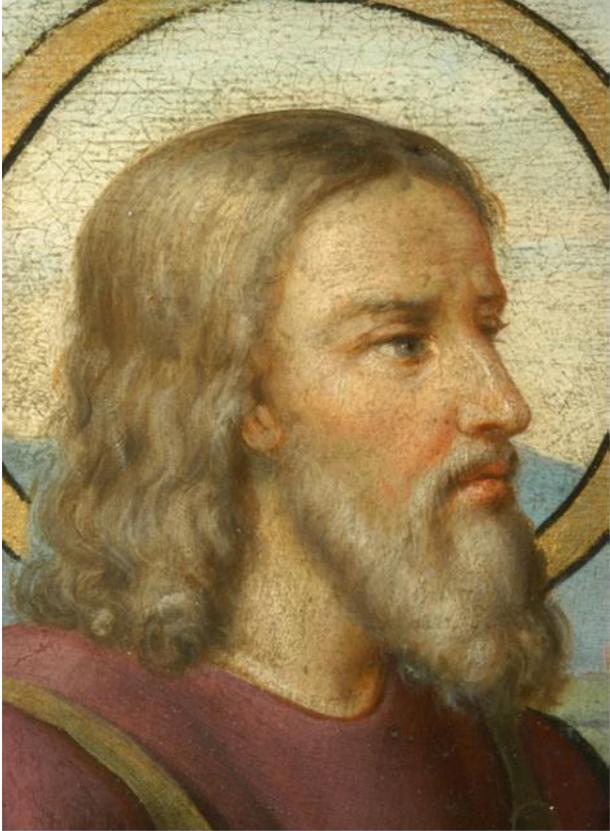
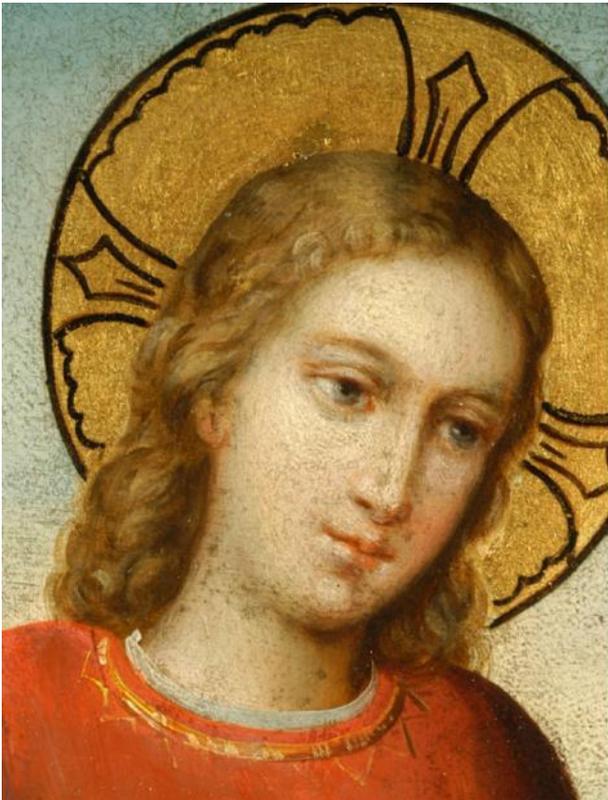
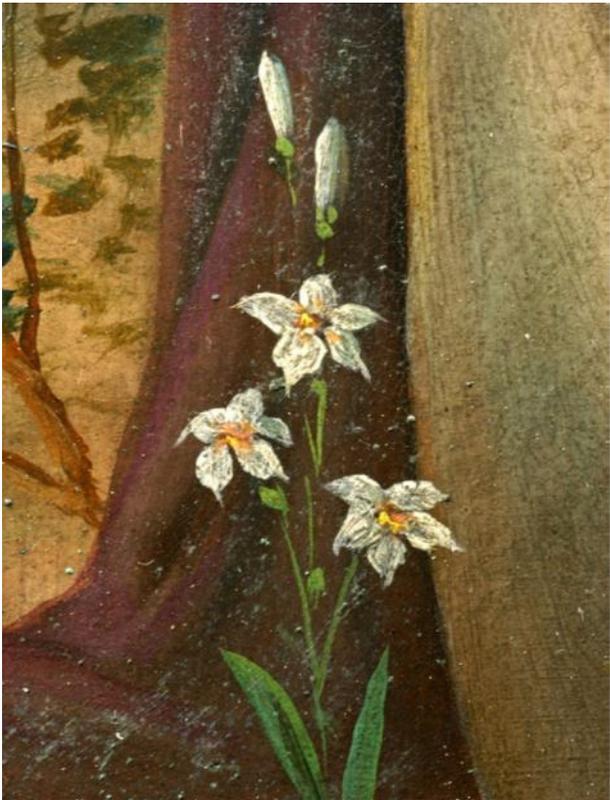
For a closer look and a possible depression in terms of style, we attach some pictures, the characteristic elements of technique and style have (Photo No. 6,7,8,9)

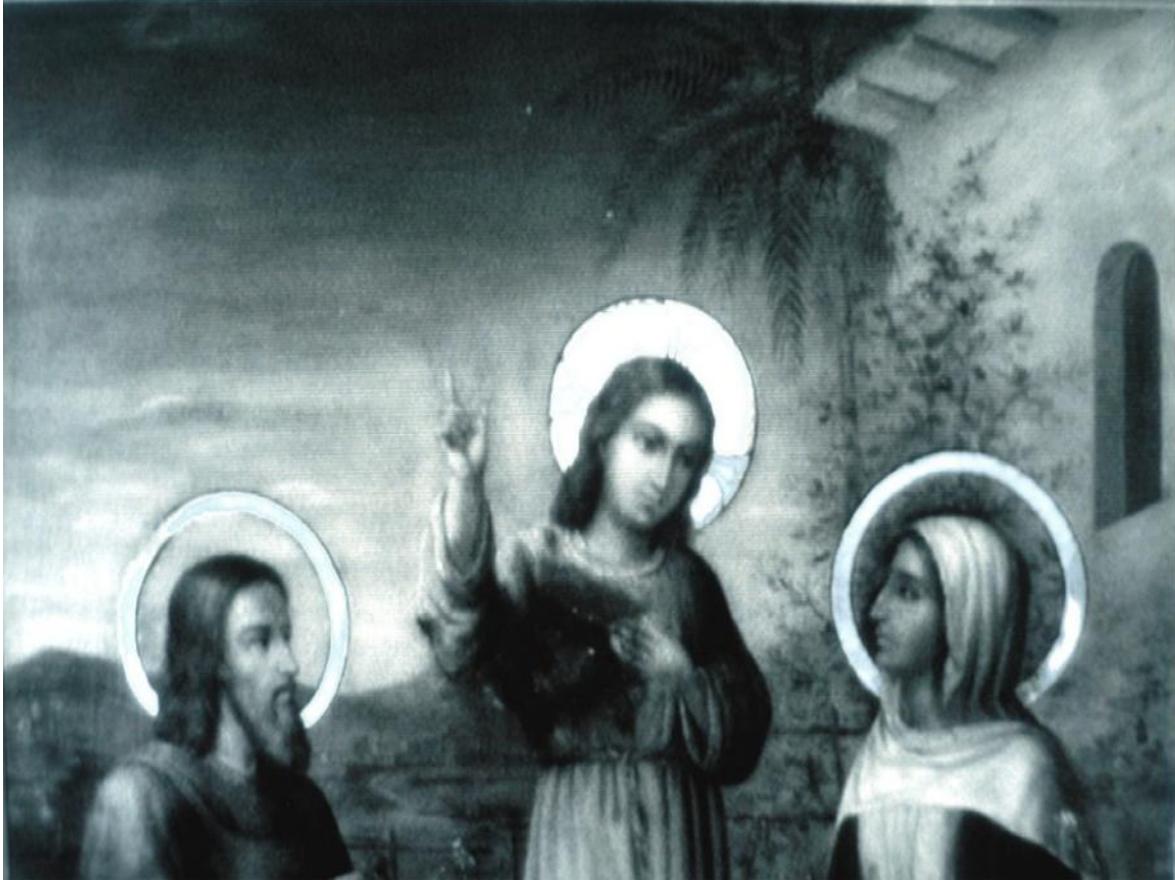
Furthermore, an IR reflectography analysis was carried out, of which we enclose some photos: Photo No. 10 and 11 from the entire image, photo No.12 from a detail of the right foot of Christ and photo No.13, from the lower right corner of the image .
